# CASE HISTORY

*SAFEBASE™ WALL ANCHORS AND HELICAL TIEBACKS*

## RIVERVIEW RETAINING WALLS

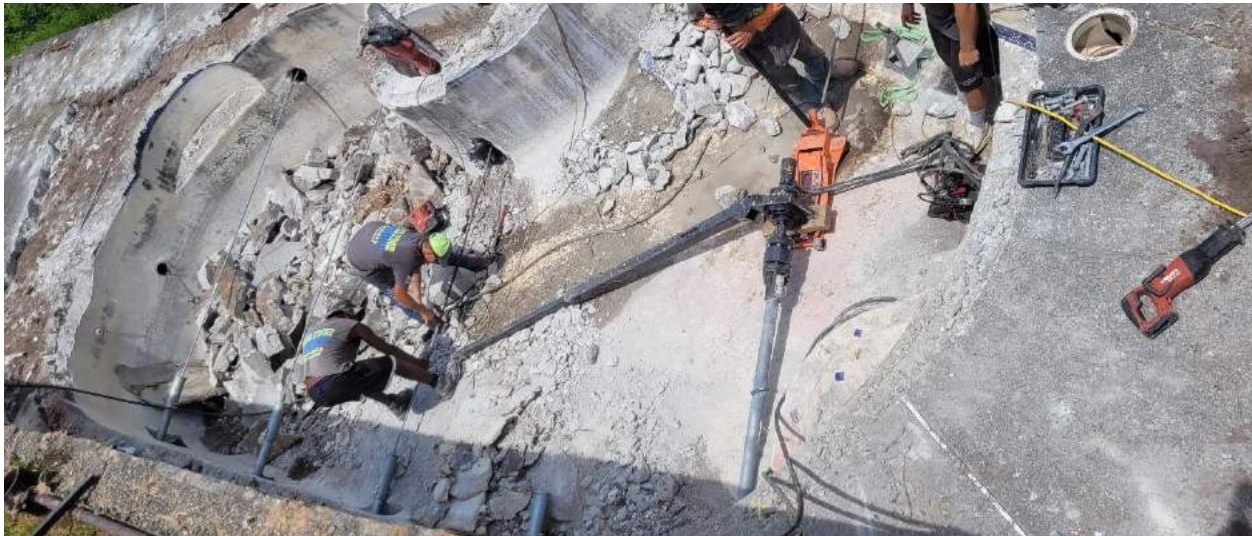
Midstate Concrete Leveling was contacted regarding a series of failing retaining walls with a pool in-between them in Riverview, Florida. A plan was made with help from local engineers and SafeBasements to support the walls with a series of wall anchors and helical tiebacks to support a new shotcrete wall in front of the old wall. Helical tiebacks had to be installed through the abandoned pool beyond the second wall with threaded rods driven through the first wall for support. The rest of the walls were supported with wall anchors.
