CASE HISTORY

SAFEBASE™ STANDARD DUTY PUSH PIERS

MINNEAPOLIS APARTMENT BUILDING STABILIZATION

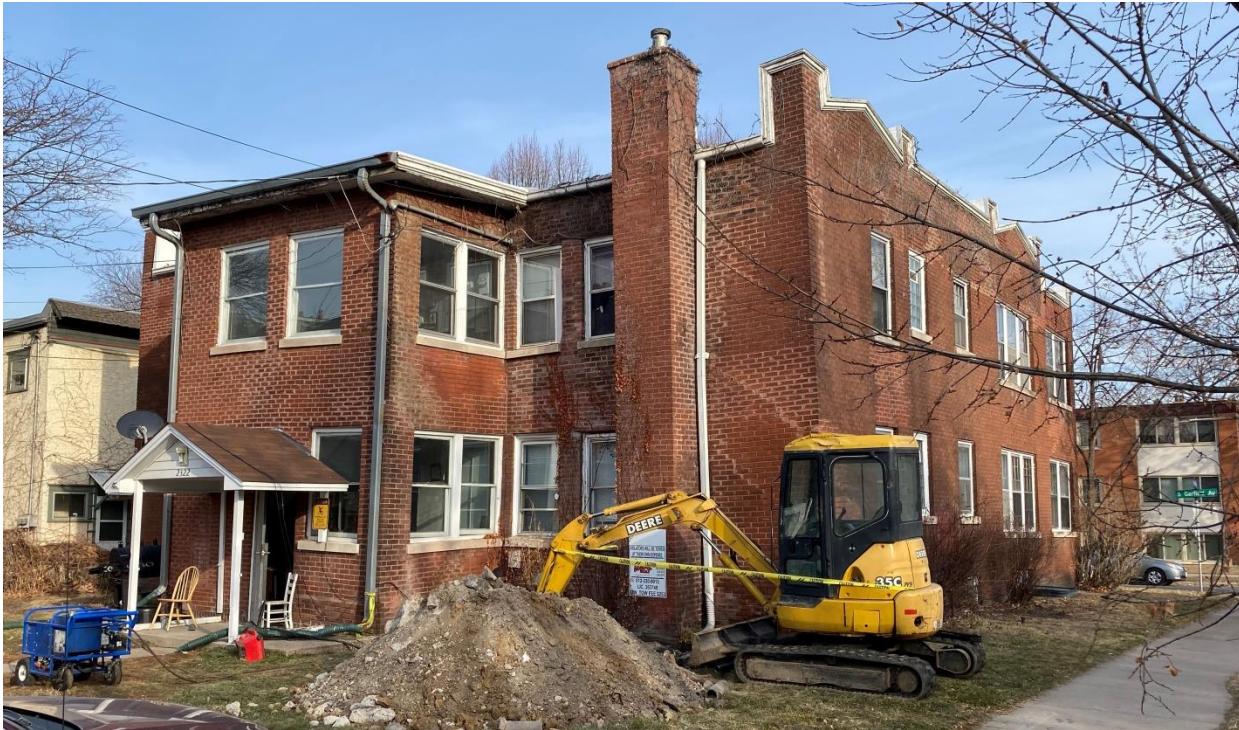
SafeBasements of Minnesota was contacted with concerns regarding sloping floors, cracks in the foundation and continual repairs needed to the brick veneer. A site visit was made and laser levels were used to take elevation measurements throughout the structure. The maximum magnitude of differential settlement was found to be 8-1/2 inches in the south west corner.

A plan was made to support the foundation with SafeBase™ 2.875" OD Standard Duty Push Piers with SafeBase™ SaberTooth™ Bracket Assemblies. A total of 22 Push Piers were installed

on the south and west sides of the foundation, 20 on the interior and 2 on the exterior supporting the chimney.

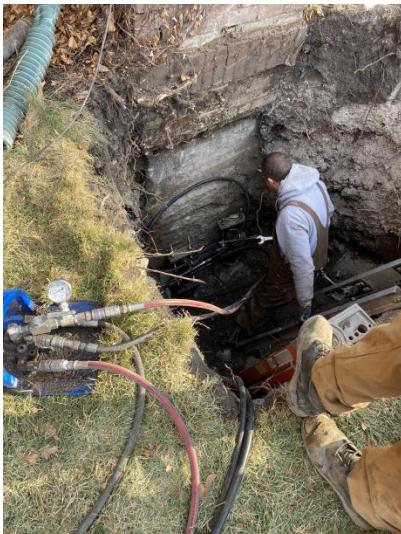
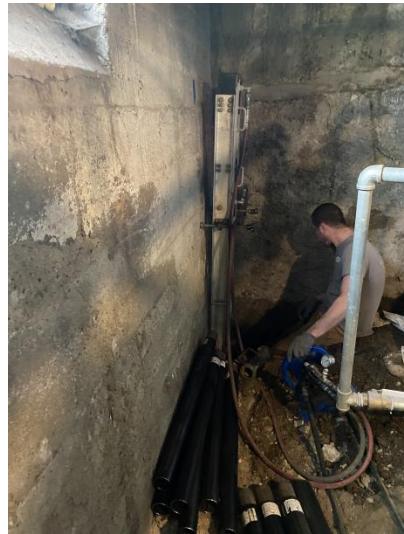
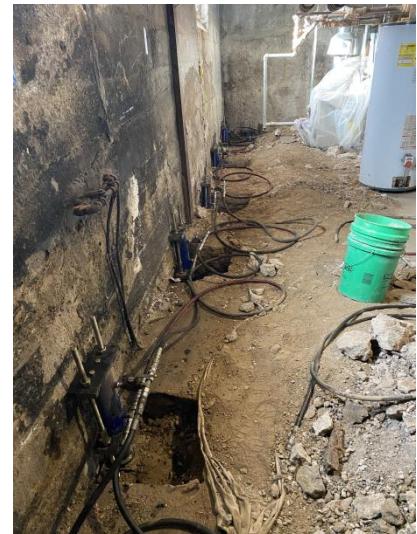
The concrete floor was removed at the location for each pier on the interior and an area was excavated near the chimney allowing access to the footing. The piers were driven using a hydraulic ram to an average depth of 58 feet with a force of 48,000 pounds per pier. After the piers were installed hydraulic lift cylinders were connected to the pier brackets in a series to allow for uniform lift of the foundation. Lasers were once again set up to monitor elevation changes during the lift. There were concerns with damaging the brick on the exterior as it had portions replaced, and patched over time, which would limit the potential for a full lift without removing and replacing the veneer. Pressure was slowly increased to the lift cylinders and checks were made on the interior and exterior for lift and any further cracking of the brick veneer. A portion of the settlement was reclaimed before new cracks started developing in the brick. At that point the nuts were tightened on the pier brackets and the load locked in place.

The foundation was now supported by the piers which were bearing on suitable stratum to prevent future settlement. Each pier was installed with a force twice as great as the load per pier, resulting a factor of safety of two. The owner decided to level the floors after the foundation was stabilized, rather than replacing the brick as would have been required to achieve a full lift. The other repairs could now be made permanently, knowing that the foundation will not continue to settle. With the installation completed the excavations could be backfilled and the access holes in the basement floor could be patched. The project was completed in December of 2020.
