# CASE HISTORY

SAFEBASE™ CARBON FIBER

## BASEMENT WALL REINFORCEMENT WITH CFRP

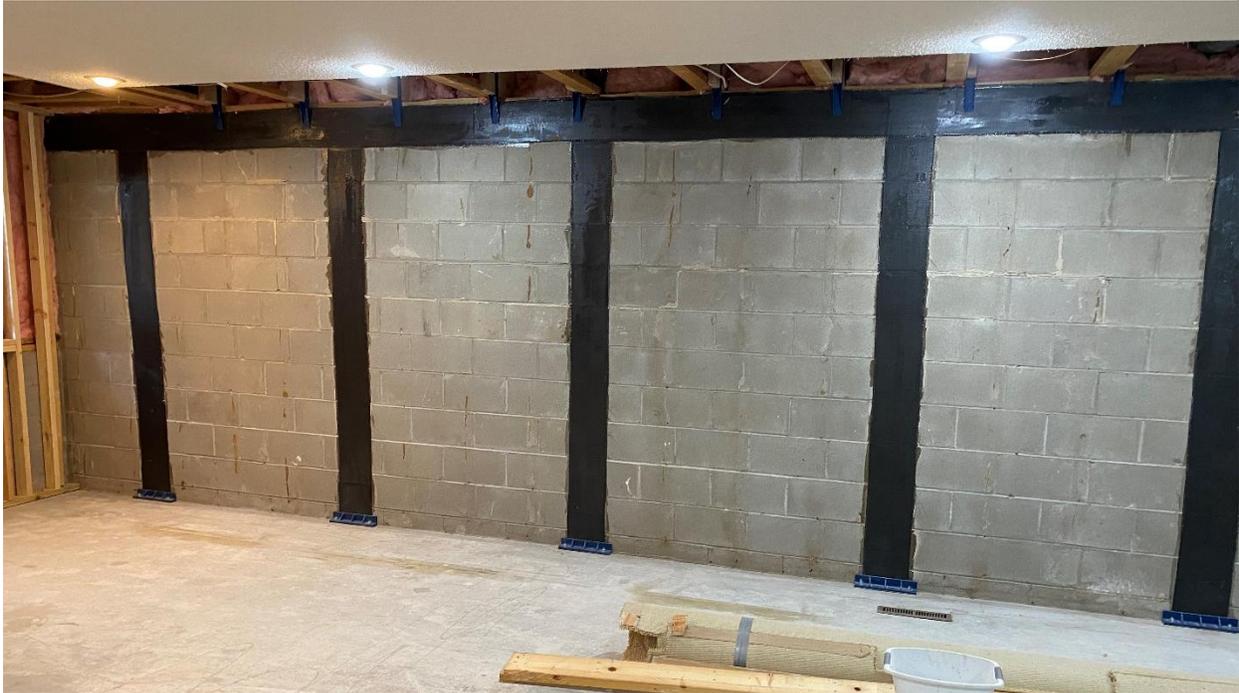
SafeBasements of Minnesota was contacted regarding issues with a bowing basement wall showing some cracks and initial signs of inward displacement. SafeBase™ carbon fiber straps were installed vertically at 5' on center along the length of the wall with a continuous horizontal strap across the top. SafeBase™ 8" wide 12K bidirectional mesh was used. The carbon fiber reinforced polymer (CFRP) strengthens the wall externally similar to how rebar would strengthen a wall internally. The carbon fiber mesh is bonded to the using a high strength epoxy. Prior to placing the carbon fiber the concrete must be ground to expose the aggregate to improve the bond strength of the system. Once the surface is ground it must be cleaned to be free of all dust. The SafeBase™ Carbon Fiber Strap is secured at the bottom of the wall using a steel bracket attached to the concrete slab.

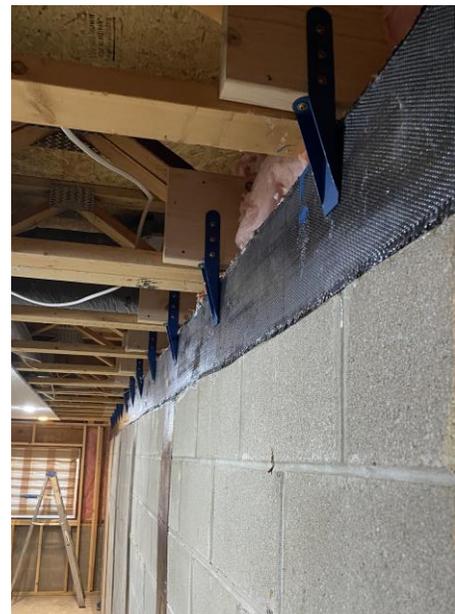
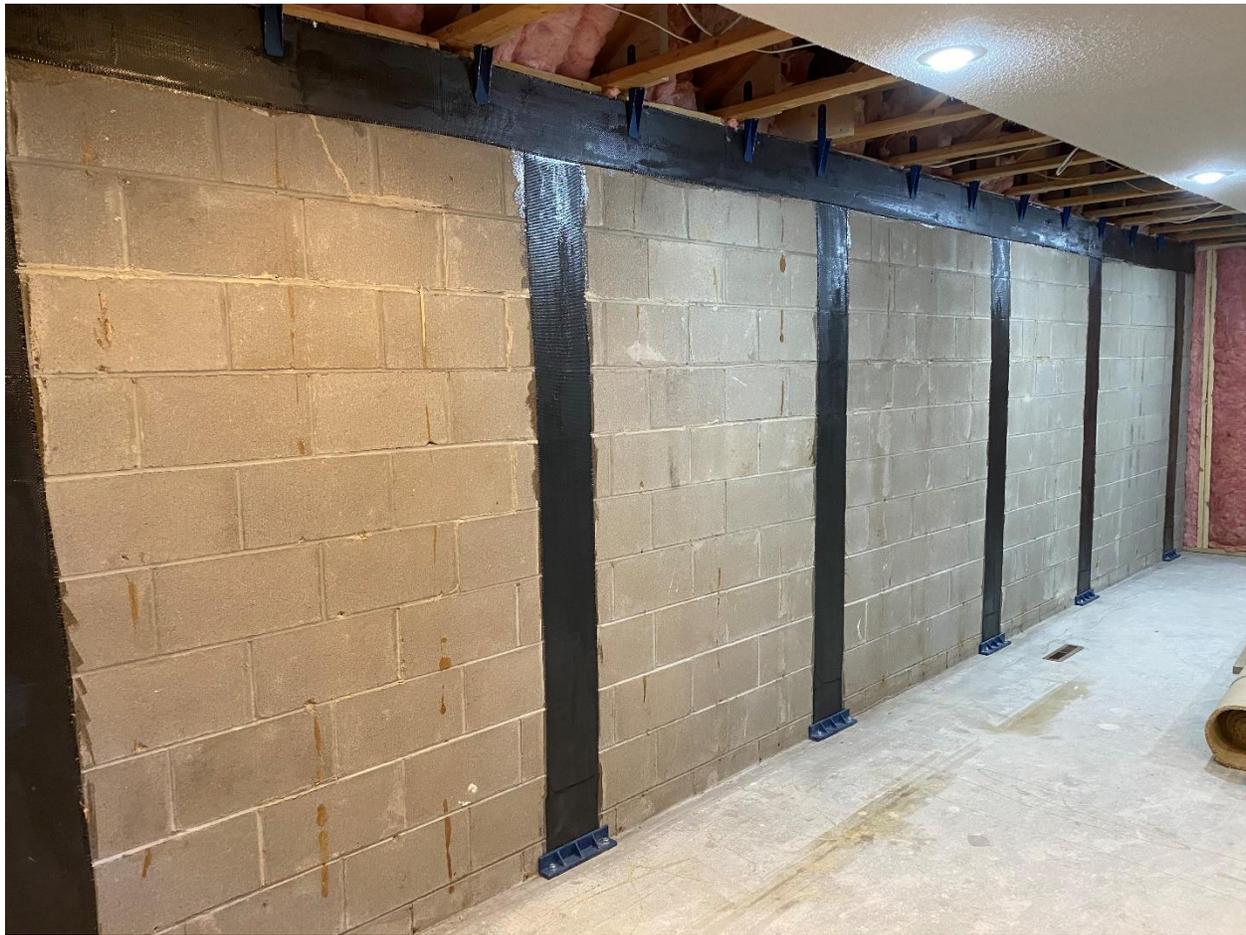
The slab bracket is composed of two pieces of steel and two anchor bolts. The carbon fiber strap is wrapped onto a flat steel plate and overlain with a reinforced steel angle and the assembly is bolted to the floor, it may also be attached to the footing if installing an interior drain tile system. At the top of the wall a series of joist brackets are attached to the floor system to prevent any tipping of the foundation wall. Two joist brackets are installed per vertical strap when the joists run perpendicular to the wall. In this case the floor system was composed of floor trusses requiring a piece of 2x10 to be attached to three members of each floor truss above the top of the wall for mounting of the joist brackets. Each joist bracket is attached with (7) 1/4x1-1/2 SDS screws or lags. The project was completed in January of 2022.
