CASE HISTORY

*SAFEBASE™ STABILIZERS, ENCAPSULATION, AND
WATERPROOFING*

CRAWLSPACE AND BASEMENT TRANSFORMATION WITH SAFEBASEMENTS WATERPROOFING

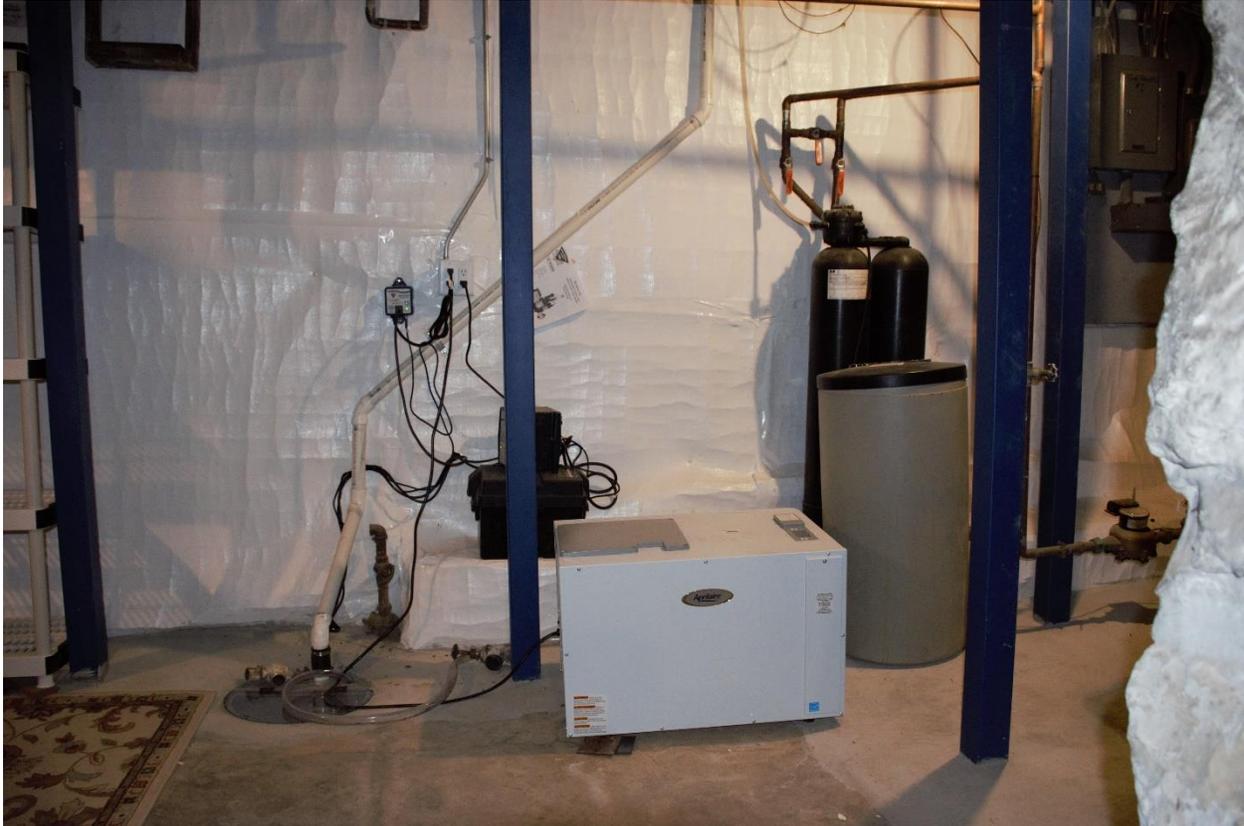
SafeBasements of Minnesota was contacted regarding several issues with a historical home located in Stillwater, Minnesota. There were moisture issues throughout the basement and crawlspaces and areas with sagging floors. SafeBasements fixed all of the issues by installing an interior drain tile system, crawlspace encapsulation, spray foam insulation, a dehumidifier and a number of supplemental supports.

A total of 190 linear feet of interior drain tile was installed. The system was composed of Multi-Flow drain tile overlain with SafeBasements Combo Floor liner in the crawlspace areas and SafeEdge MAX in the basement areas. A SafeBasements MPT100 Sump Basket collected the water and it was discharged using a Pro-Series pump. An AprilAire 130 dehumidifier also was installed to reduce the moisture in the air and drained into the sump basket. 1677 sq ft of Combo Liner was installed on the floors and 875 sq ft of foil backed 90 mil liner was installed on the walls. 168 bd-ft of rim joist spray foam insulation was installed along the exterior walls. Several areas with sagging floors were supported with a total of 26 SafeBase™ Stabilizers with Light Foot XL footings. 5x3x1/4 SafeBase Waler tubing was used as supplemental beams spanning from stabilizer to stabilizer supported by SafeBase™ Beam Cradles.

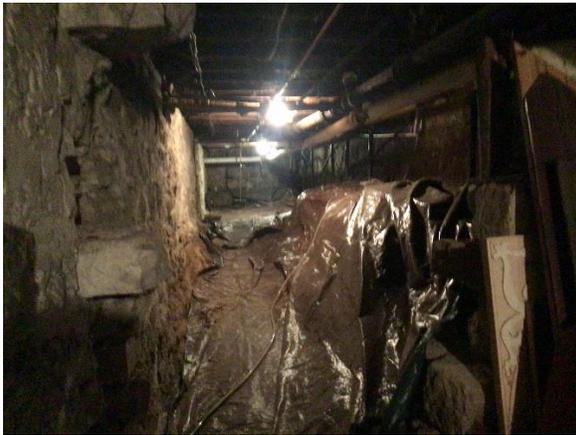
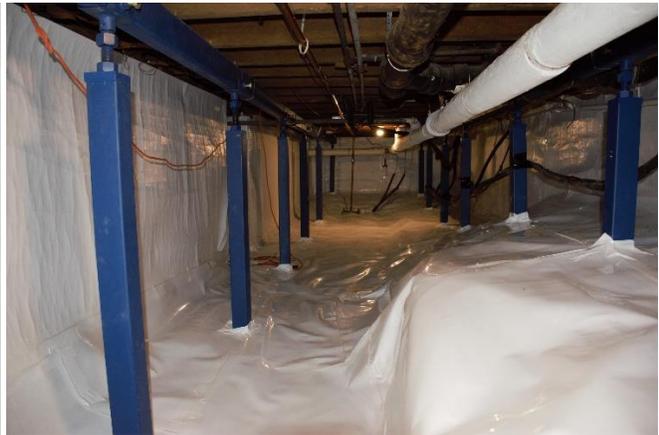
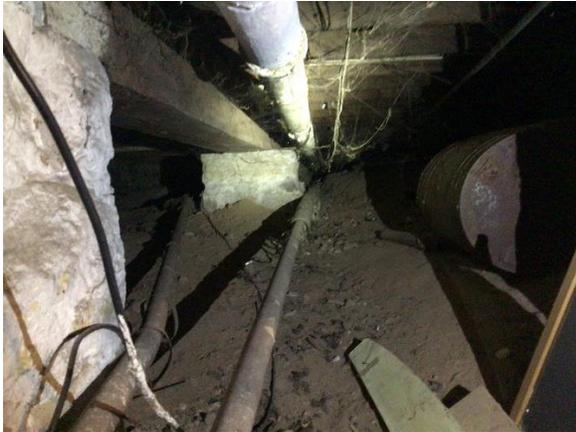
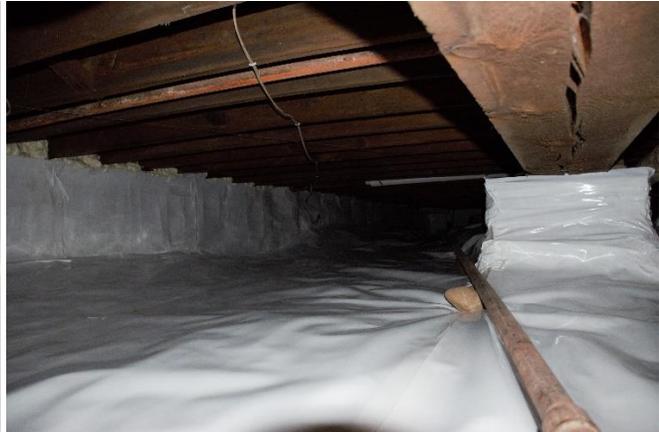
Above on the left are photos of the basement and crawlspace from before the work was completed and on the right are photos from afterwards. The SafeBasements 90 mil wall encapsulation and SafeBasements combo liner on the floor transform the damp, dirty, old crawlspace into a clean, dry, radon free space. The project was completed in April of 2022.
