CASE HISTORY

SAFEBASE™ PUSH PIERS, WALL ANCHORS, CARBON FIBER STRAPS AND WATERPROOFING

RESIDENTIAL FOUNDATION REPAIR AND WATERPROOFING

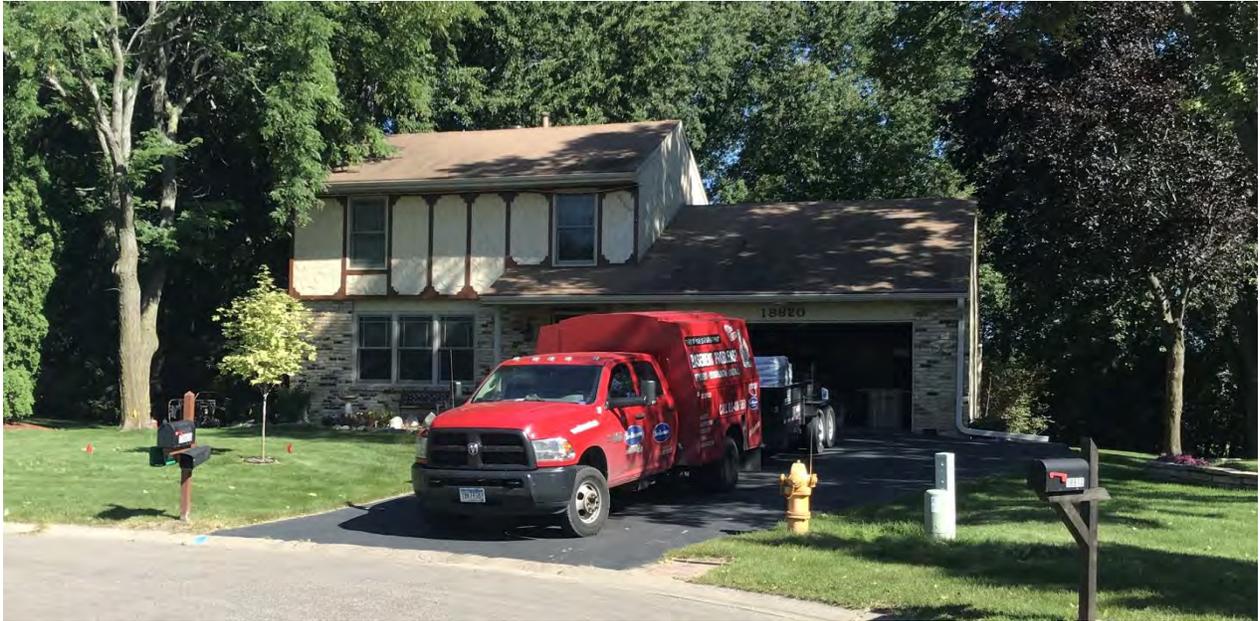
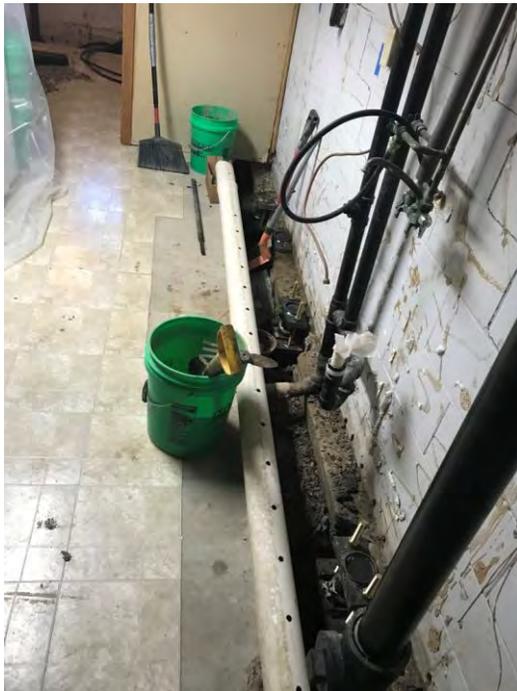
SafeBasements of Minnesota was contacted by a homeowner who was noticing cracking and shifting in their foundation. An evaluation was performed and it was determined that three of the basement walls were experiencing bowing and settlement. A plan was made to support the settling foundation with SafeBase push piers, while laterally supporting the foundation walls with a combination of SafeBase wall anchors and carbon fiber straps. The homeowner chose to only do a portion of the work at this time, approximately half of the affected area, so no lifting would be performed. The push piers were installed on the interior of the home, requiring removal of the existing drain tile system.

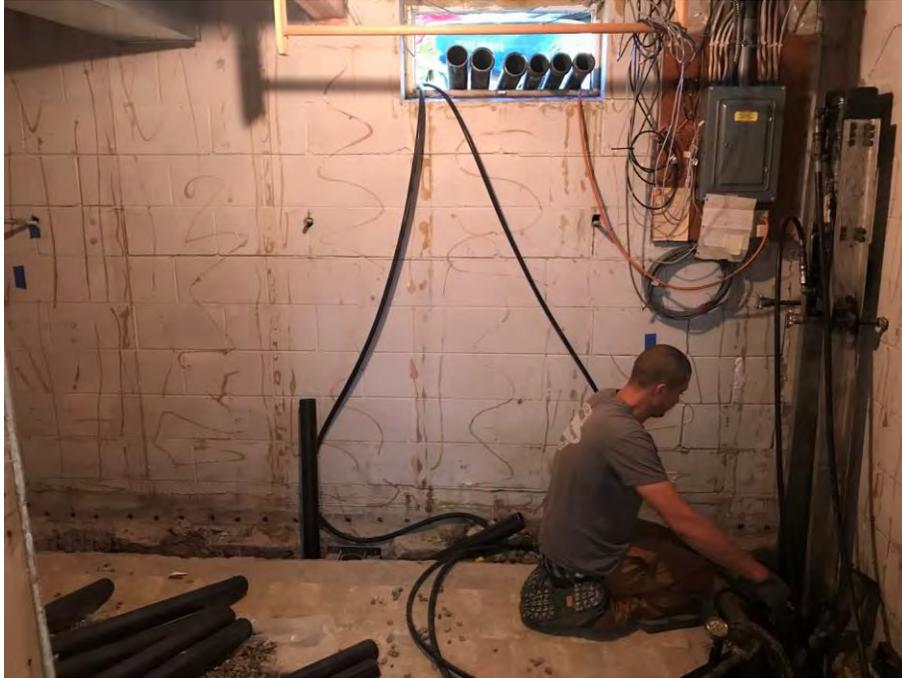
Wall anchors were installed on the west wall to prevent further bowing, and give the ability to straighten the wall. SafeBase push piers with SaberTooth bracket assemblies were used, allowing for a low profile installation, and the advantage of not having to shim the bracket in the waterproofing trench.

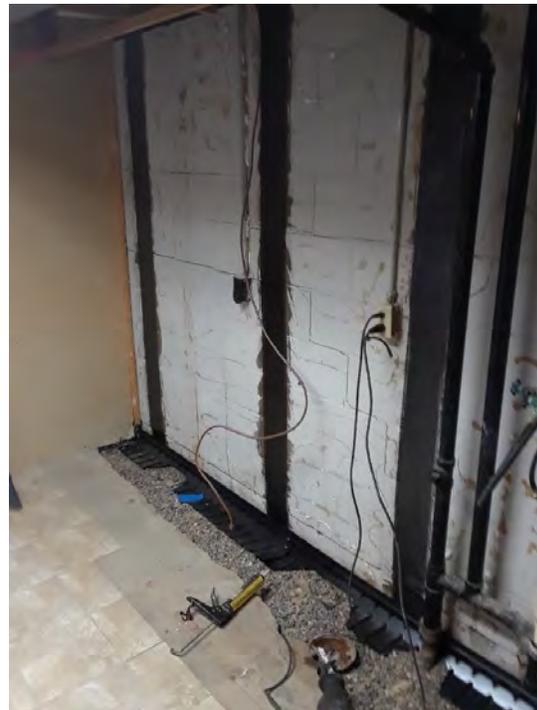
Carbon fiber straps were installed on the north wall due to obstructions in the yard preventing the installation of wall anchors. The drain tile system was then re-installed and SafeEdge Max was used as an edging. Note the carbon fiber tied in behind the edging and the areas that were notched in the SafeEdge Max at the pier locations. The all thread rods were cut off at the top of the cap prior to placing the edging and pouring back the concrete. The SafeEdge Max has the advantage of having contact directly between the slab, foundation wall and footing after the concrete is replaced. The walls that were repaired will remain intact for the life of the home.
