CASE HISTORY

24" CARBON FIBER BIDIRECTIONAL MESH

CITY OF HARPER WATER TOWER

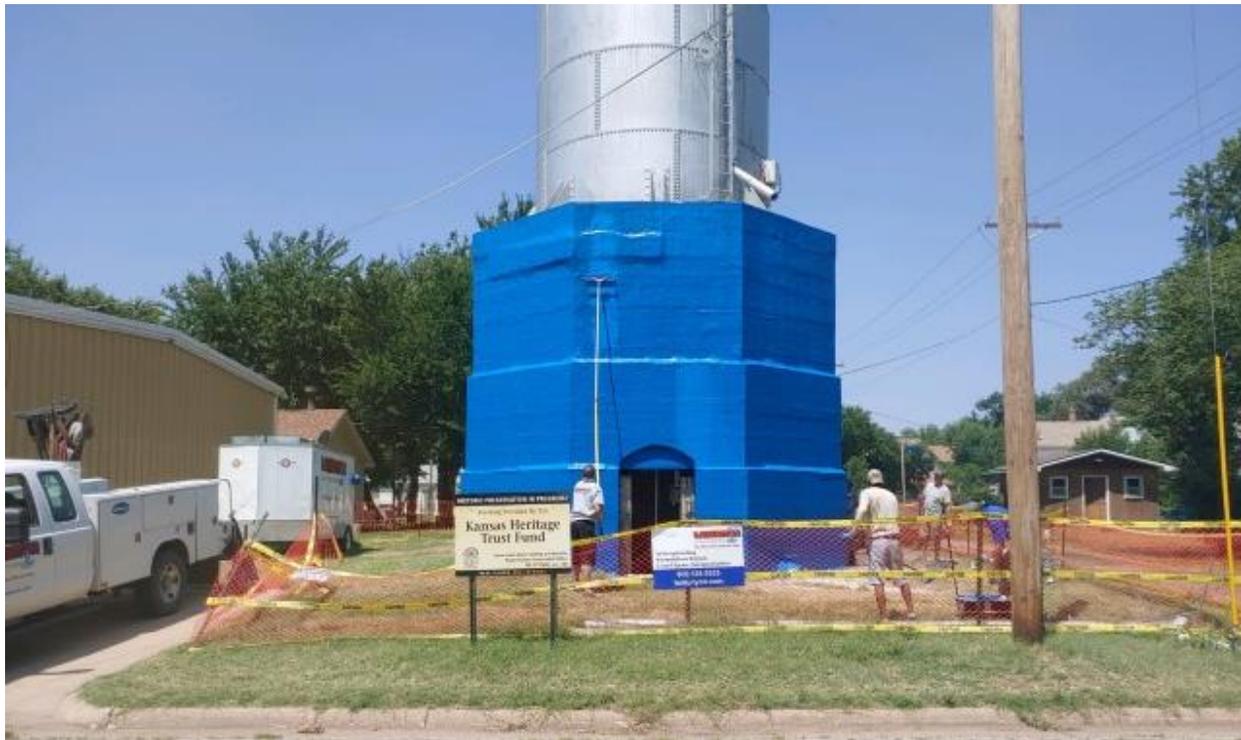
Lamunyon Dry Out and Foundation Repair were given the opportunity to save one of the oldest existing Standpipe's in Kansas. Built during 1886 & 1887 and is a very unique example of late 19th century construction and is still actively used by the surrounding community. The tower base was originally made of brick. The brick base had been continually failing for years. The first attempt at a repair was to encase the brick in concrete. When that repair failed, metal rods were installed around it to try to keep the concrete from failing any further, but that didn't work either.

Lamunyon's solution was to use 24" bidirectional carbon fiber mesh to hold the base together. With a tensile strength that's nearly ten times more than steel and five times lighter. This is one repair that should hold up much longer. Two layers of the 24" carbon fiber bidirectional mesh were installed; one covering the surface oriented horizontally, and one covering the surface oriented vertically.
