CASE HISTORY

SafeBase[™] Class 178 Helical Tiebacks

Excelsior, MN

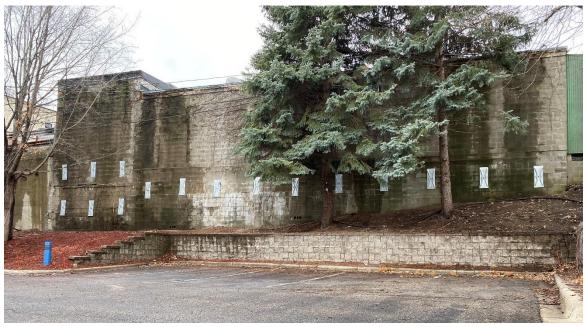
SafeBasements of Minnesota was contacted with concerns regarding a tipping and bowing retaining wall supporting a gas station in Excelsior, MN. The displacement of the wall was causing some displacement of the soil supporting the footings for the buildings above, and some cracking of the masonry walls above. SafeBasements created a plan for supporting the retaining wall with SafeBase[™] Class 178 Helical Tiebacks.

After the helical tiebacks were torqued up, tieback adapters were connected with threaded rods, the holes were patched, and wall plates installed on the exterior of the retaining wall. The owner will no longer have to be concerned about lateral displacement of the retaining wall.

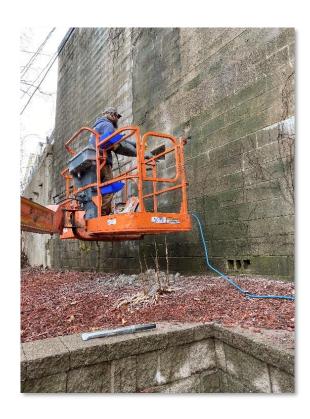
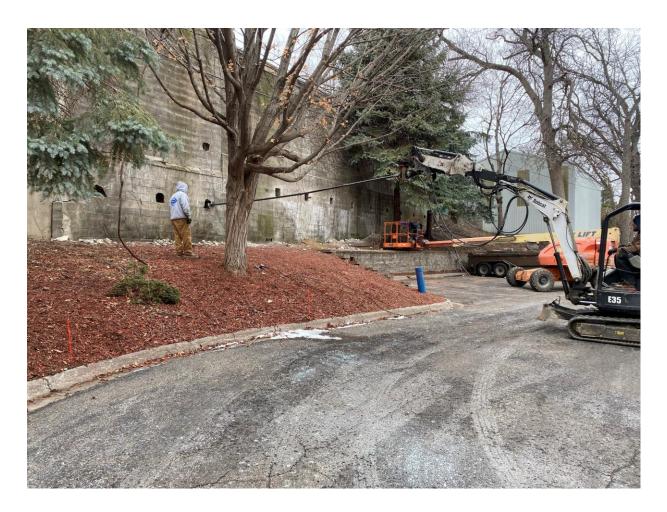
Holes were made through the retaining wall approximately 6' on center that would allow for the helical tiebacks with 8" and 10" flights to be screwed in.

Several of the helical tiebacks encountered a buried obstruction approximately 14' behind the face of the wall. It was assumed that this was an old masonry foundation/retaining wall that was buried beneath the car wash portion of the gas station. The patent pending helical pier with industry leading cross tip technology pulverized the buried obstructions, saving thousands of dollars in change orders for removal and replacement of slabs and excavating to remove the obstruction. The helical tiebacks were installed up to lengths of 23' without having to make any other modifications to the scope of the project.
