CASE HISTORY

*SAFEBASE™ CARBON FIBER & SAFEBASEMENTS™
WATERPROOFING*

BASEMENT WALL STRENGTHENING, WATERPROOFING, AND DISPLACEMENT PREVENTION

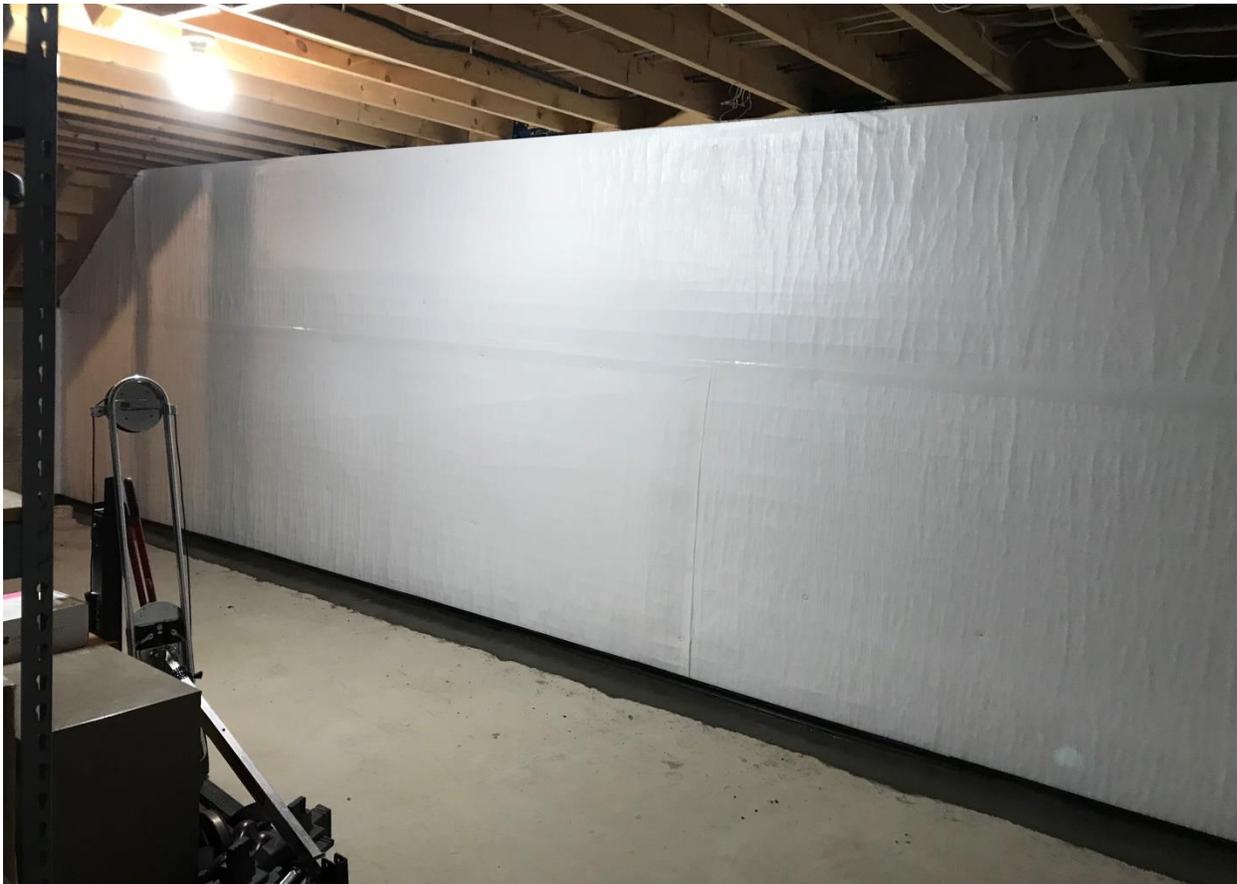
SafeBasements of Minnesota was contacted regarding concerns about movement of the basement walls and water intrusion. A plan was made to reinforce the walls using SafeBase Carbon Fiber and install an interior drain tile system with wall encapsulation. The concrete floor was removed near the base of the wall and Multi-Flow drain tile was installed in a bed of pea rock connected to a sump pump.

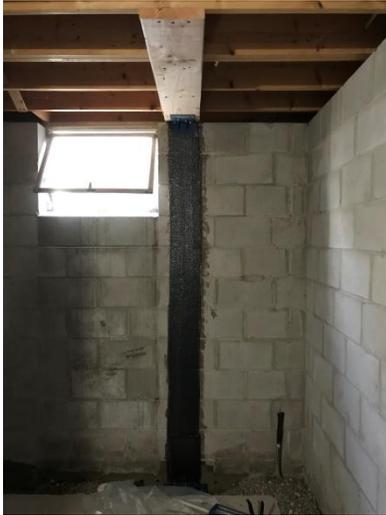
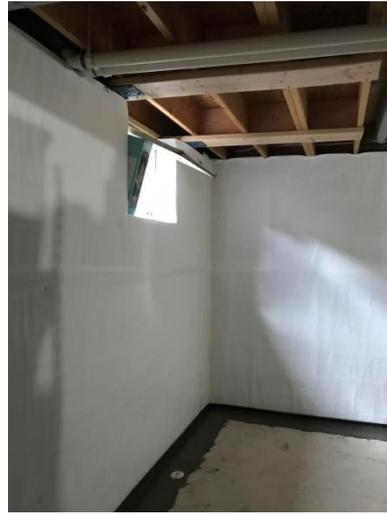
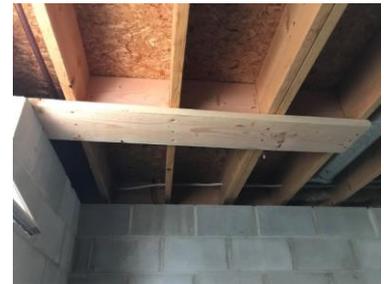
The surfaces of the walls were then prepared to accept the 8 inch wide bi-directional carbon fiber mesh. The carbon fiber is wrapped and epoxied to a steel bracket that bolts to the floor joists at the top of the wall. The bottom of the strap is wrapped through a steel bracket, overlain onto itself and bolted to the footing. The entire carbon fiber strap is adhered to the wall and brackets with high strength epoxy. The SafeEdge Max installed over the brackets, to allow any water within the wall to drain out the weep holes and into the drain tile system. A total of 10 Carbon Fiber straps and 90 feet of drain tile were installed.

Where the floor joists are running parallel to the wall, the top bracket is restrained by installing solid lumber blocking within the joist spaces.
