# CASE HISTORY

*SAFEBASE™ PUSH PIERS*

## PALO ALTO GRADE BEAM STABILIZATION

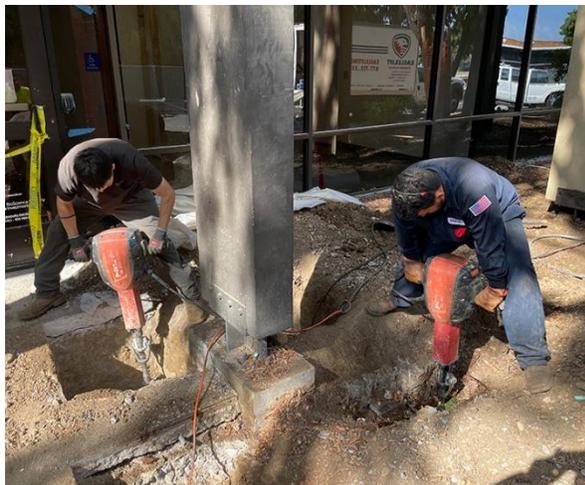
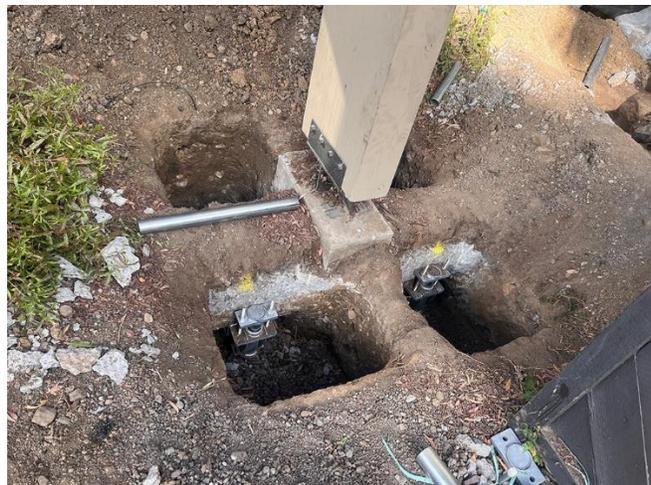
A two-story commercial structure in Palo Alto, CA was experiencing settlement along its northeastern face. The building's overhanging second level was supported by support columns that sat upon a reinforced concrete grade beam that ran the entire length of the building. Due to vertical loads and poor surface soil conditions, consisting of bay mud that was below a layer of artificial fill, the grade beam experienced a settlement of more than 3 inches. Due to the settlement, the grade had reversed and was causing water to pool near the building.

To address the settlement, EagleLIFT proposed to stabilize and lift the beam using 4 SafeBase™ Light Duty galvanized steel push piers with Light Duty SaberTooth™ Brackets at each support column, equaling 52 push piers for 13 columns. The piers were installed in an offsetting pattern at a 4' separation on either side. This design was used to limit direct pressure at a specific point in the grade beam to alleviate potential stress and damage. Each push pier was installed at 80' depths to reach competent strata. Initial estimates, per the geotechnical investigation, were that Alluvial materials would be encountered at 14 – 20ft below the bay muds. To reach the minimum 9 kips and 1900 psi, we had to drive the tubes to 80'.

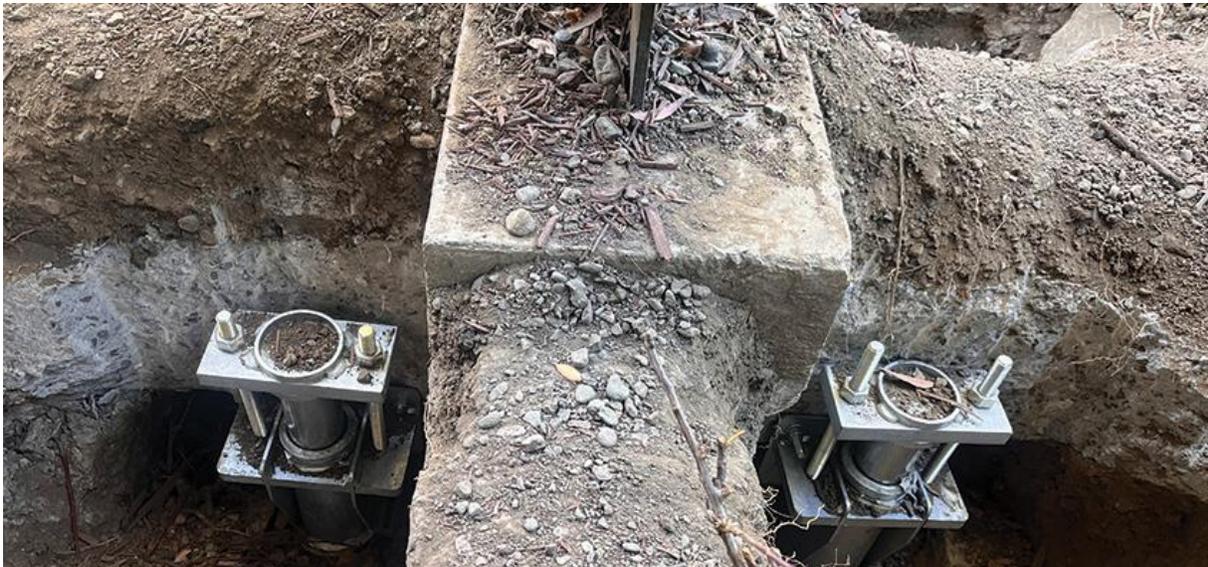
The project took place over 15 days. Light excavation equipment was used in low traffic hours to minimize impacts on the building residents. During the project, a full-time site inspector was onsite to monitor pier logs, psi, bracket installation, and pier installation. The grade beam, support columns, and the overhang of the second floor were fully stabilized. The project was completed in November of 2022.
